Chemical analysis and microstructure of concrete after long-term exposure to LILW repositories condition – Part II

PERCO2 / WP1 – Durability testing of existing
concrete specimens

Fahim Al-Neshawy and Abobaker Ba Ragaa

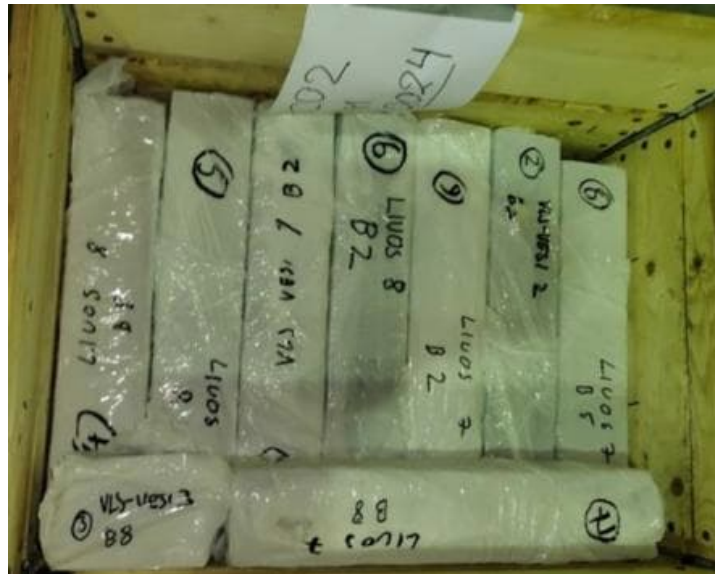
Figure 4. Selected concrete specimens for the investigation.

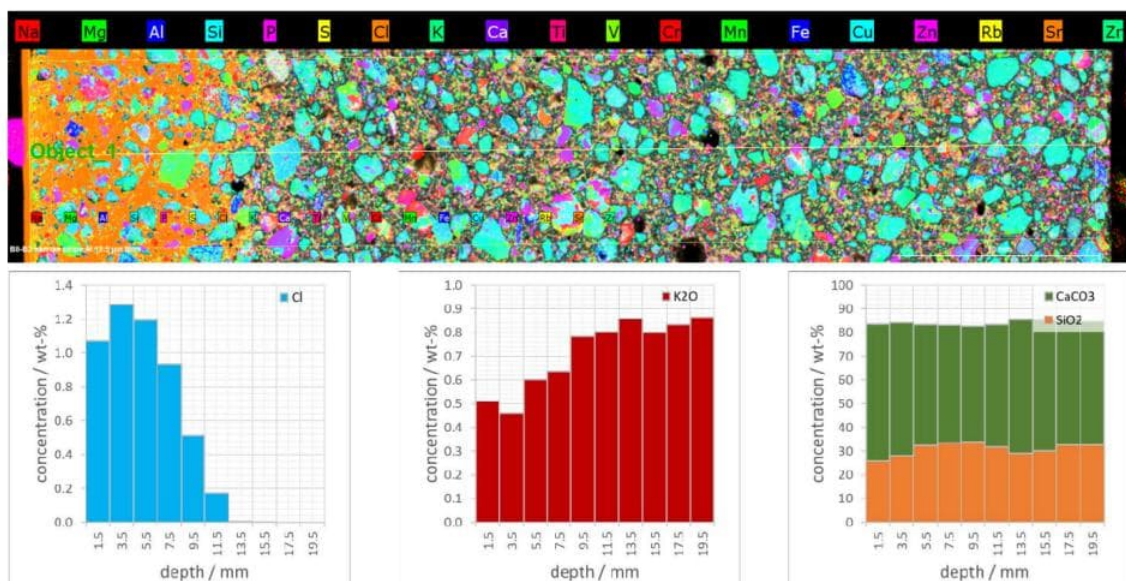
Figure 9. Examples of the Micro X-ray fluorescence (micro-XRF) distribution maps of some chemical compounds in concrete [15].

As an example, presented in Figure 9, drawing out a series of objects allows for semi-quantitative analysis: The HyperMap data can be used to tell the aggregates apart from the cement and quantify the cement composition into the depth of the sample. In this example, the Cl concentration goes from 1 wt.% to 0 wt.% within the first 10 mm. The K concentration is anticorrelated to the Cl (leaching). The sum of SiO₂ and CaCO₃ is stable at about 85 wt.%.

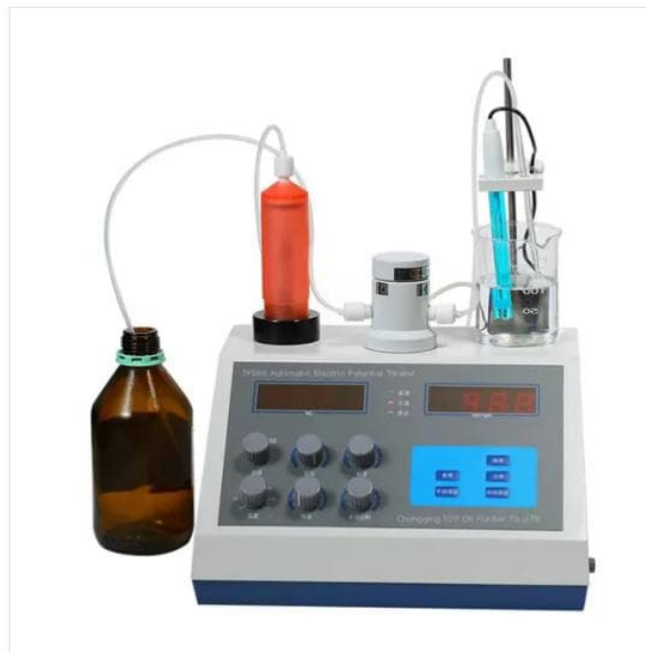
Figure 10. Example of the potentiometric titrators used in the titration method.

Chloride titrations are carried out to determine the ingress of chloride ions of the concrete surface. The measurement of chloride profiles is determined by applying the standard m EN 14629 (Products and systems for the protection and repair of concrete structures - Test methods - Determination of chloride content in hardened concrete, method B, potentiometric titration). The potentiometric titration belongs to chemical methods of analysis in which the endpoint of the titration is monitored with an indicator electrode that records the change of the potential as a function of the amount (usually the volume) of the added titrant of exactly known concentration.

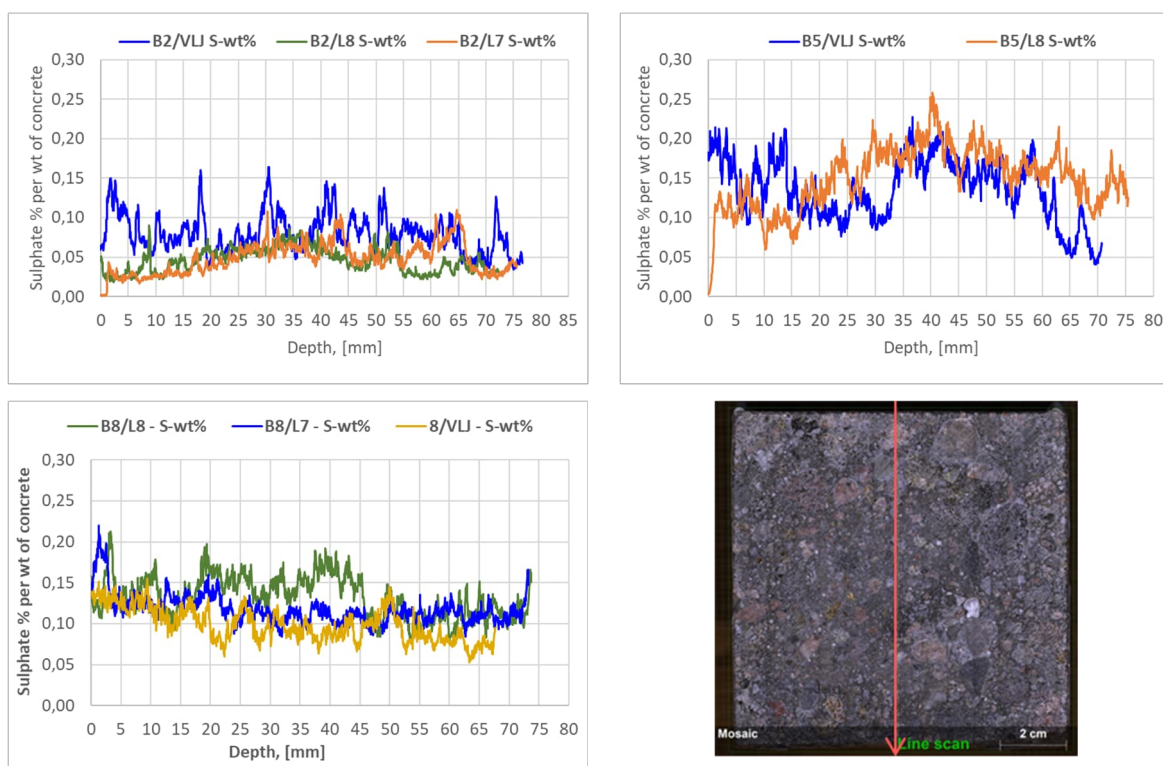
Figure 18. Details of the sulphate profiles of the different concrete samples.

The micro-XRF measuring head is mounted on a remote-controlled X-Y-Z stage which enables to execute high spatial resolution line-scan and area mapping providing multi-element analyses on areas with maximum dimensions of 75×75mm². Element distributions across the sample are then originated by dedicated software. The details of the measurement line-scan of the sulphate profiles are presented in Figure 18 and the area mapping is presented in Appendix (A).

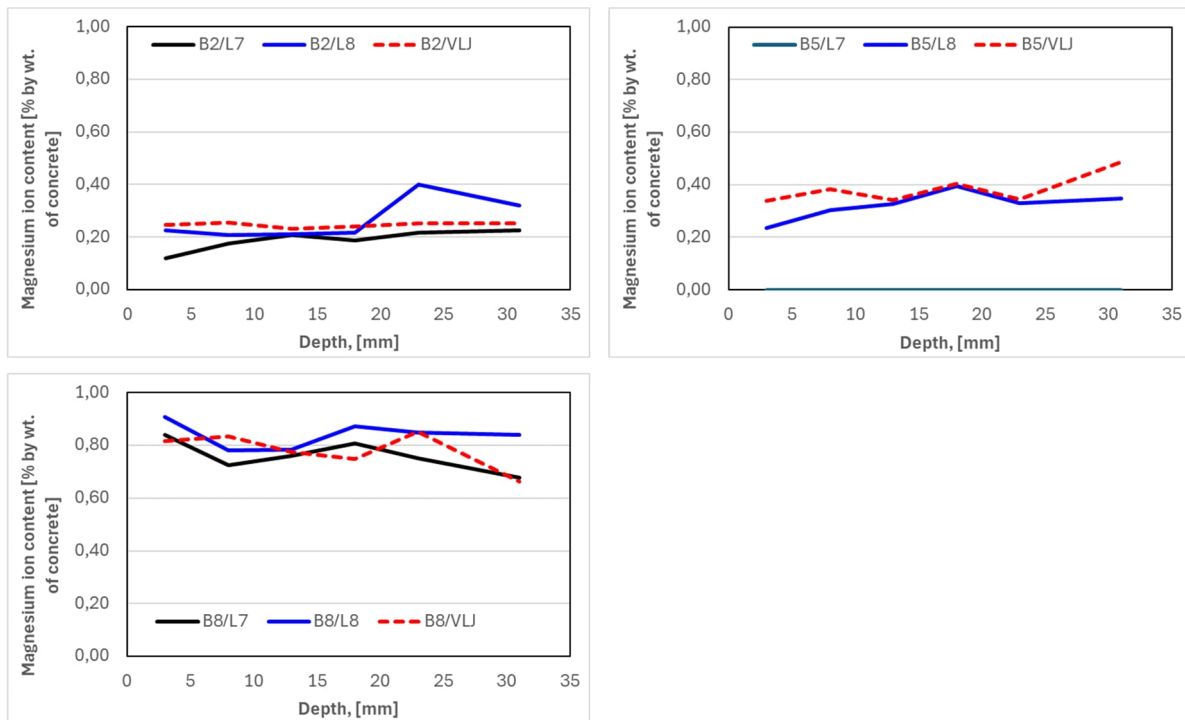
Figure 19. Magnesium profiles for concrete specimens.

Based on the results of the magnesium micro XRF analysis, it can be seen that the concrete specimens that were made with GBFS binder (B8) generally have much higher magnesium content compared to the other samples under all storage conditions. This is expected, due to the slag having high(er) magnesium content in its mineral phases. Overall, similar to the sulphate profiles, the results did not show any noticeable trend, and the charts obtained have been flat for the most part (the values are not higher on the surface for example). This makes it difficult to justify whether the magnesium content is ingress or if it is from the mix

materials. By using the micro XRF method, the content of magnesium in general is determined, but determining the mineral phases that it exhibits is not, which also complicates this procedure. The values are, in general, relatively low. The details of the measurement line-scan of the magnesium profiles are presented in Figure 20 and the area mapping is presented in Appendix (A).

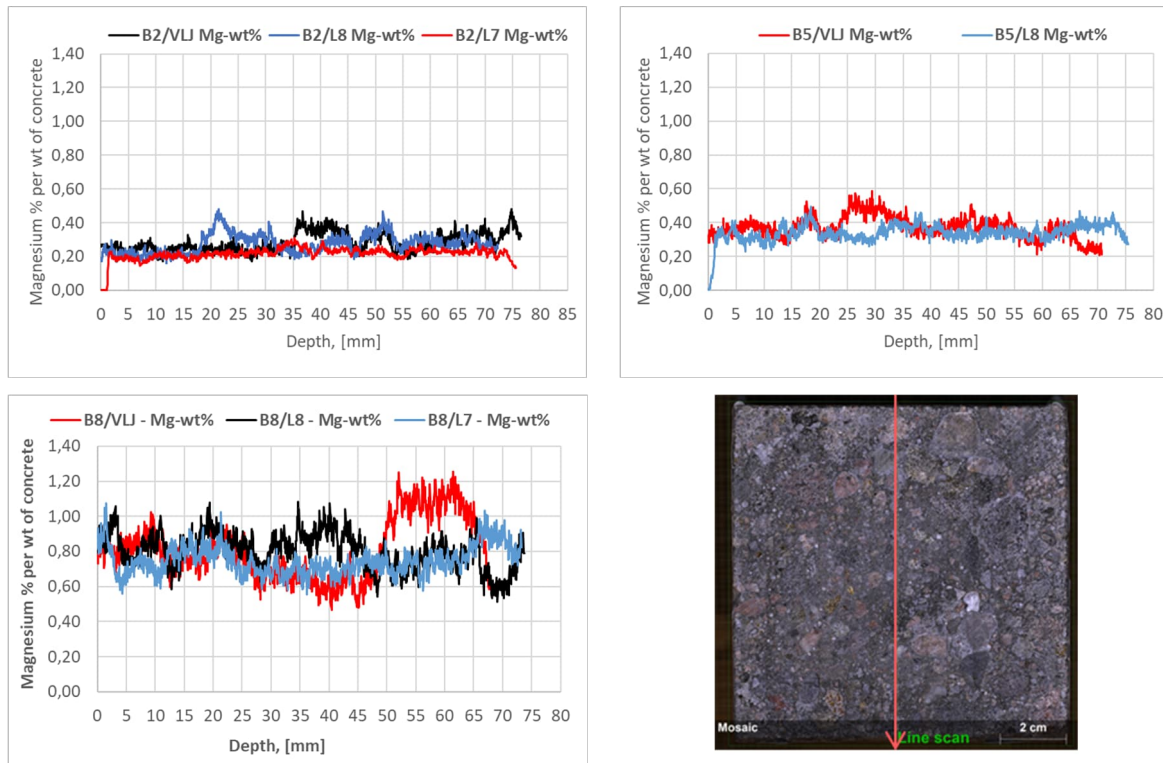
Figure 20. Details of the magnesium profiles of the different concrete samples.

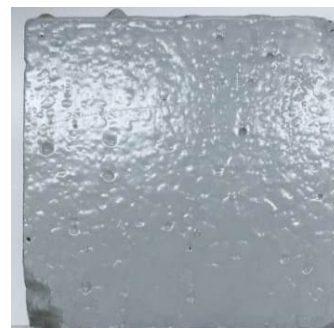
B5/L8 – Epoxy coating

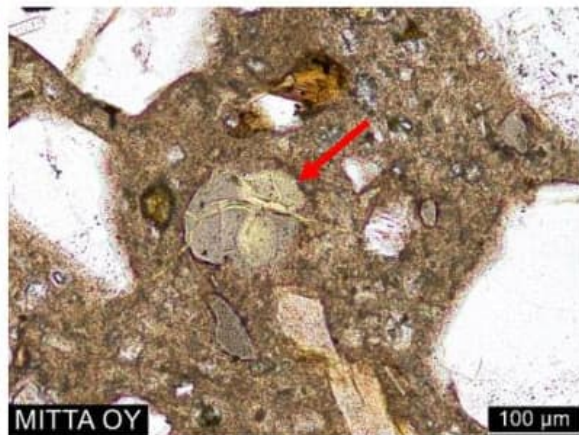
Figure 32. Cracking has proceeded to the paste from the silica fume lump. PPL
