Research report

# SCC tests for thermally cycled specimens and metallographic characterization

Ahmed Mazhar, Risto Ilola, Iikka Virkkunen

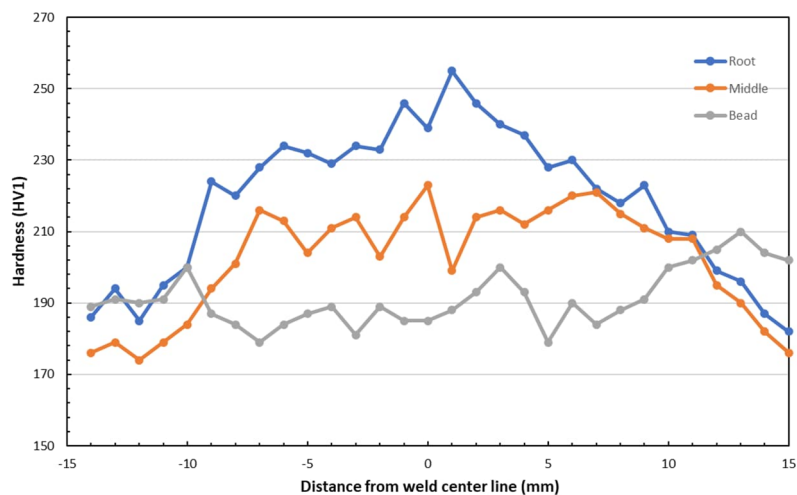
Figure 3. Hardness profile of the weld measured from the root side, bead, and middle of the weld.

Hardness profiles measured from three different locations of the weld cross-section before the autoclave exposure tests are presented in Figure 3. Hardness values were the greatest in the weld root location being of order of 250 HV1 at maximum. The lowest hardness values were measured on the bead side of the weld. The hardness of the base material was below 200 HV1, which is typical for the pipe material in solution annealed and quenched condition.

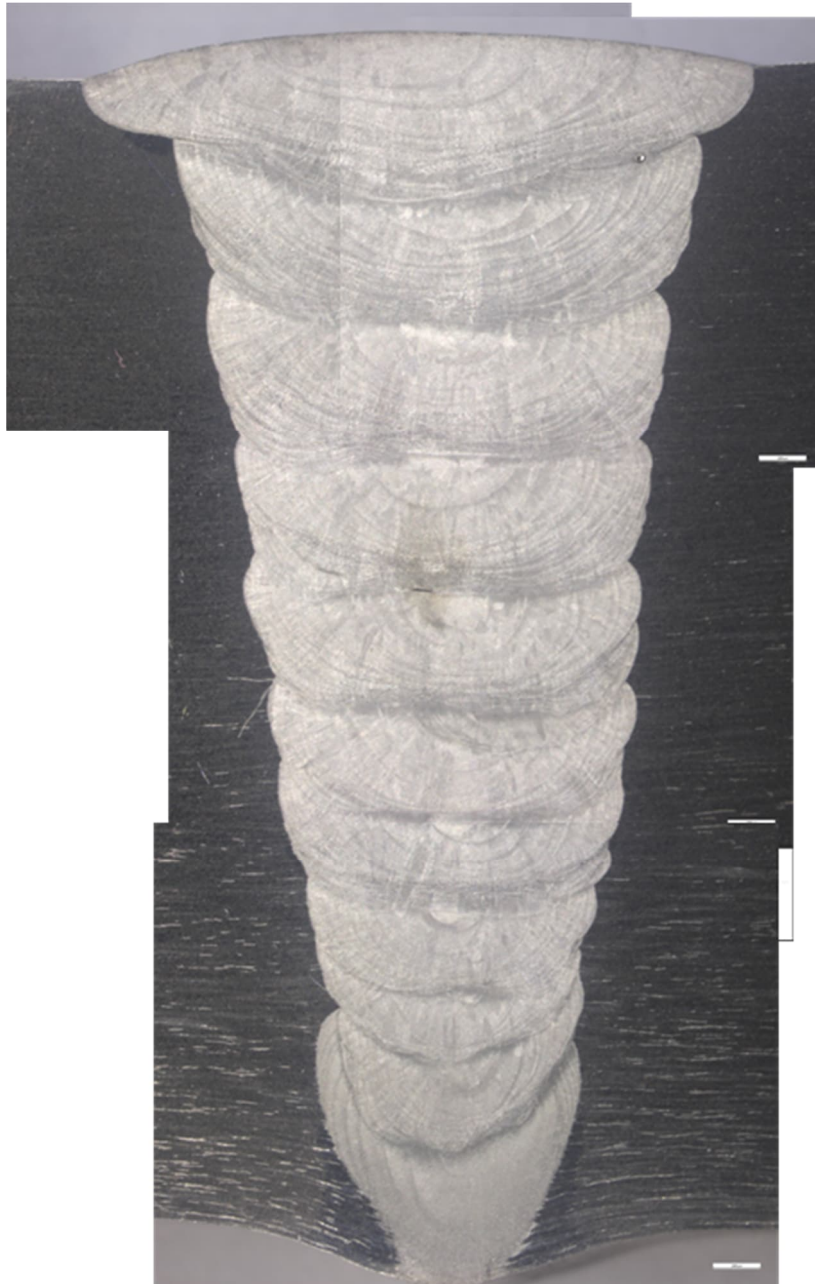
Figure 4. Cross-section of the studied AISI 316 NG-GTAW weld (pipe thickness 33 mm).

Macrostructure of the weld cross-section is presented in Figure 4. The weld consists of 13 welding runs.

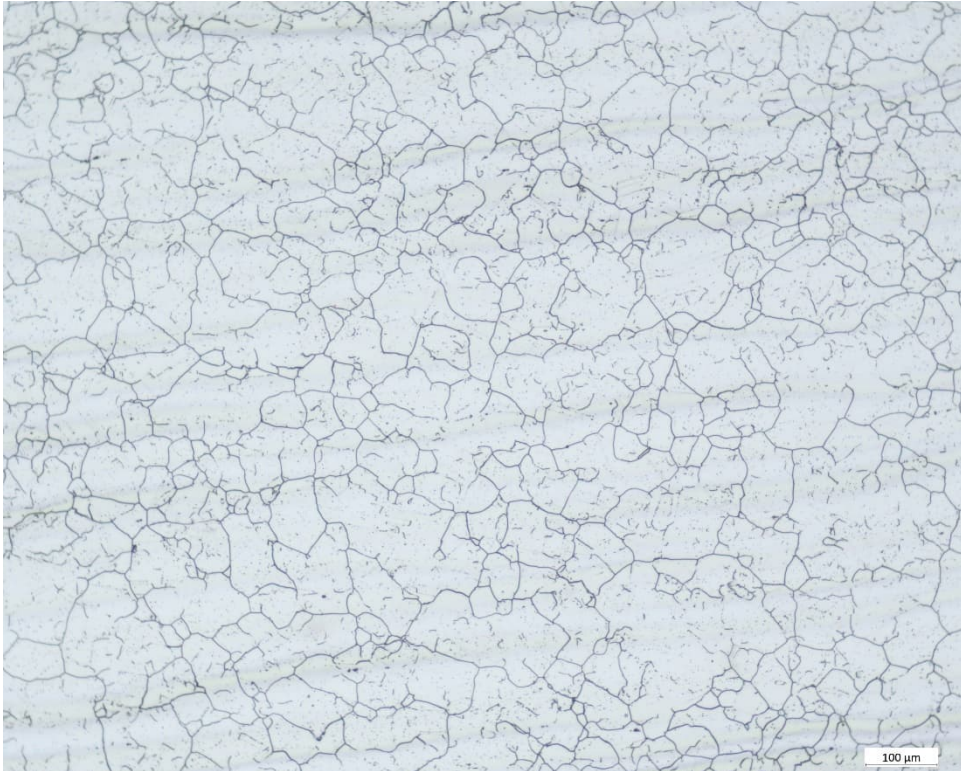
Figure 5. Austenitic microstructure of the base material, average grain size  $G = 6$  (scale bar 100  $\mu\text{m}$ ).

The base material microstructure was typical to solution annealed austenitic steel (Fig. 5) having some individual elongated delta ferrite stringers (Fig. 10). The measured average grain size number  $G$  was 6. The orientation of delta ferrite was along the direction of deformation formed in pipe manufacturing (Fig. 15). In the weld, the delta ferrite was not elongated, and it was distributed uniformly. Columnar weld solidification that was perpendicular to fusion line was observed (Figs. 9 and 11). Only in the vicinity of the weld root, a HAZ region zone was seen (Fig. 7).

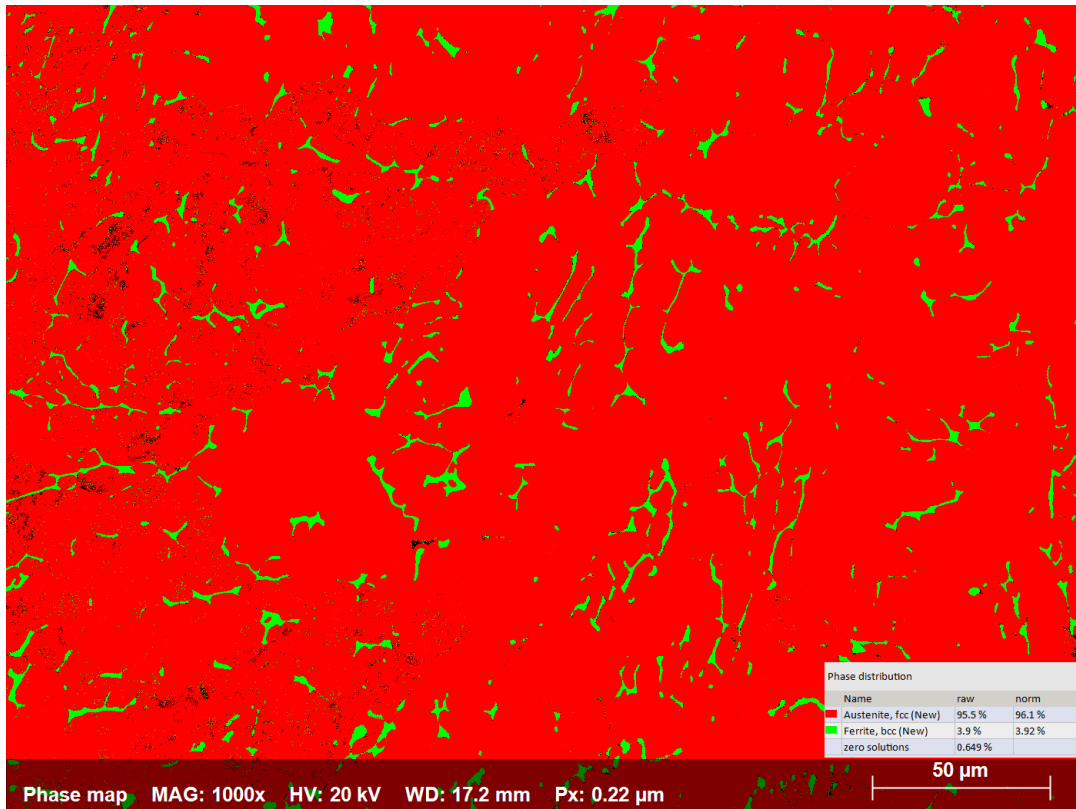
Figure 14: Phase map taken from the weld showing 96% austenite and 4% delta ferrite.

The second phase found in optical microscopy was identified as delta ferrite in SEM-EBSD phase mapping in weld (Figure 14) and base material (Figure 15). The delta ferrite content in the analysed region was 4 %.

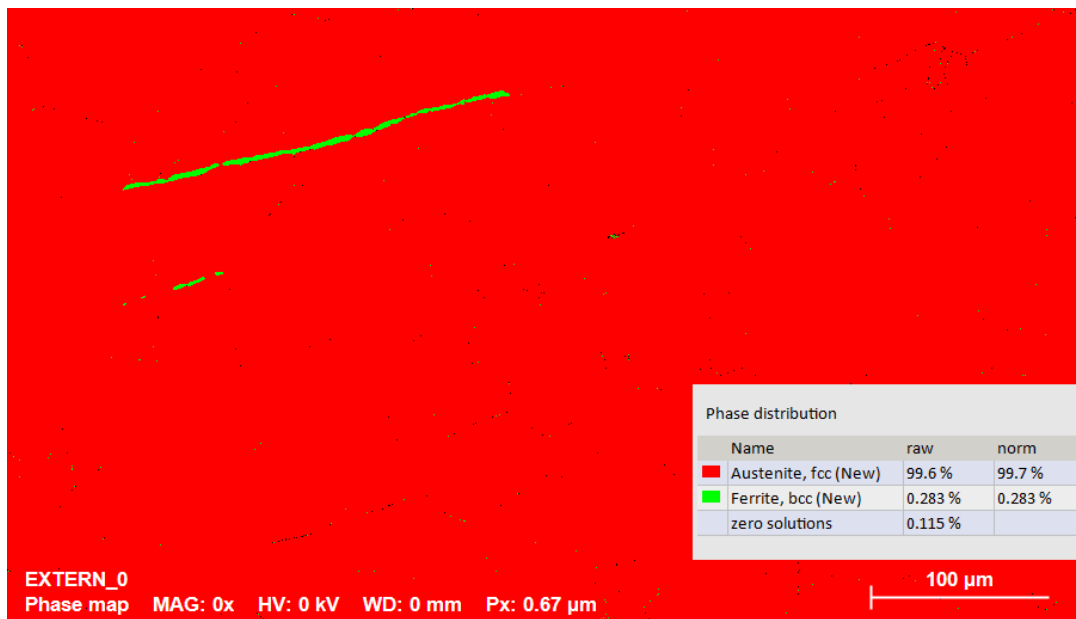
Figure 15. Phase map taken from the base metal showing delta ferrite stringers within austenite.
